# Manhole Inspection Summary

Manhole # S21GG2023MH

Insp Date: **11/17/06 11:23 AM**

**Location** Address: **5820 CLARKS HILL**

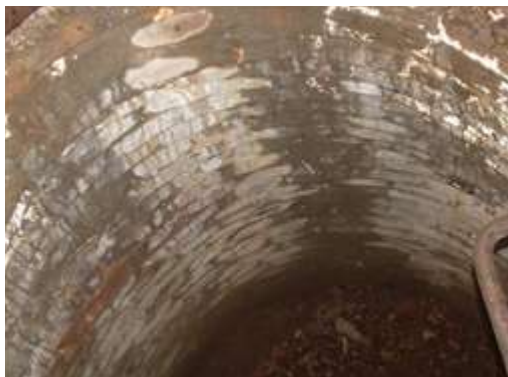
Defect

Channel debris.

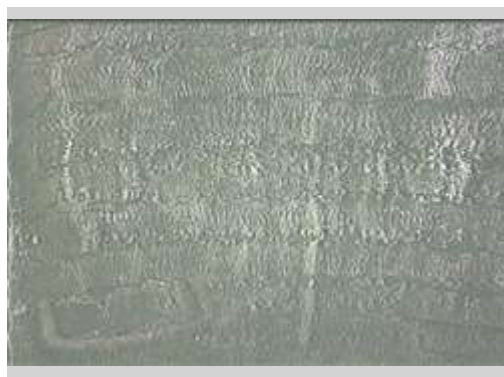
Defect

Infiltration: ☐ None ☒ **Joint** ☐ Cracks ☒ **Mortar** ☐ Roots ☒ **Wall**

Infiltration: ☐ None ☐ Joint ☐ Cracks ☒ **Mortar** ☐ Roots ☒ **Wall**

Adjustment and Barrel infiltration.

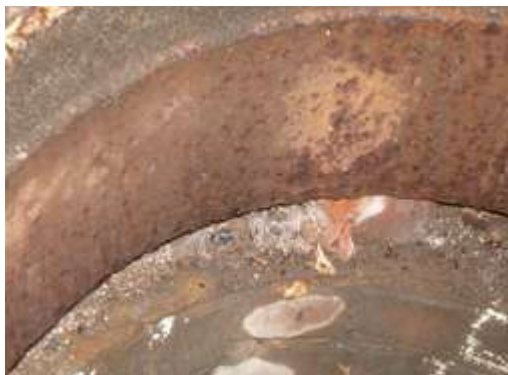
Defect 4

Condition: ☐ Sound ☐ Cracked ☐ Root Intrusion ☐ Loose Brick ☒ **Deteriorated**

Barrel deterioration and infiltration.

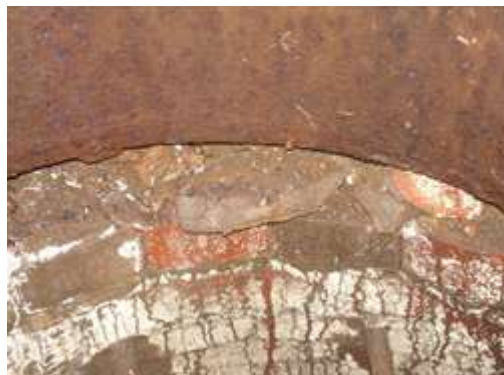
Defect

Frame offset. Adjustment deterioration and infiltration.

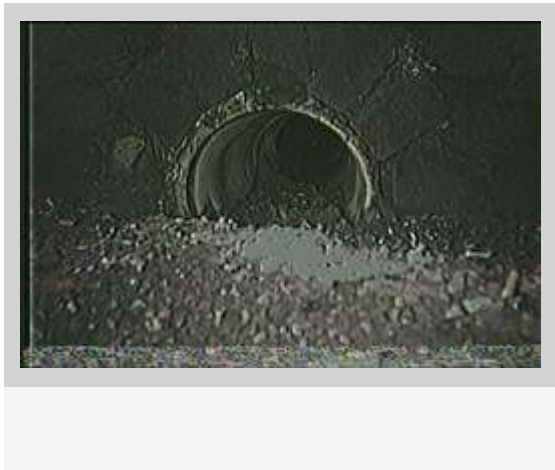
8 in. Circular Gravity Sewer  
Pipe Out @ 12 O'Clock

Condition: ☐ Sound ☐ Cracked ☐ Root Intrusion ☒ **Loose Brick** ☒ **Deteriorated**

Adjustment infiltration, deterioration, and loose brick.
